Fractured file Lower molar

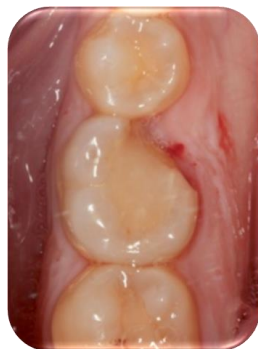
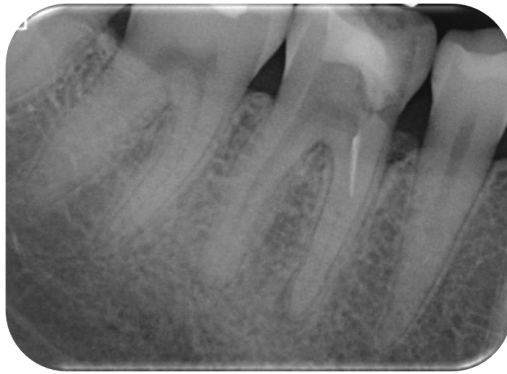
Root canal treatment of tooth 46 had been started 4 months ago by her GDP, however an instrument was fractured in the mesio buccal canal. Her symptoms began six months ago after the filling initially fractured.

In this case, a stainless steel hand file had been fractured early on in the instrumentation procedure, leaving infected tissue beyond the remaining canal. This would significantly affect the prognosis of the tooth unless the instrument was removed or bypassed.

All endodontic treatment was carried out using a dental operating microscope over two visits. The coronal part of the fractured instrument could be seen in the MB canal and the access cavity was modified to create straight-line access to the fragment. A few millimeters of the coronal aspect was exposed using ultrasonic instruments. The ultrasonic tip was gently placed in contact with the fragment and rotated in a counter clockwise direction, which resulted in displacement of the fragment.
