This case describes the non-surgical management of teeth 16 and 22 and surgical management of tooth 23.

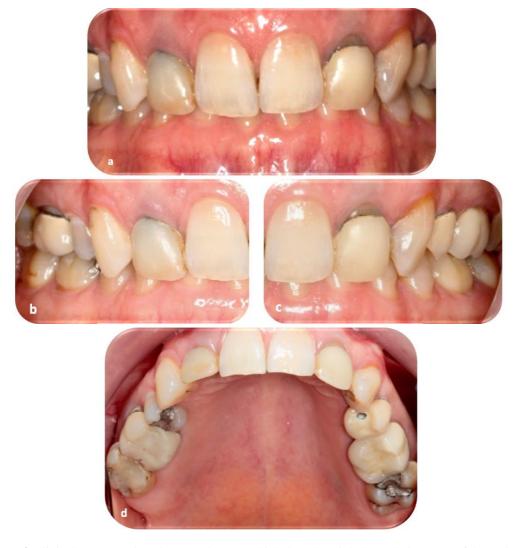
Figure 2 Clinical pre-operative photographs. (a) Labial view (b) Right buccal view (c) Left buccal view (d) Upper occlusal view

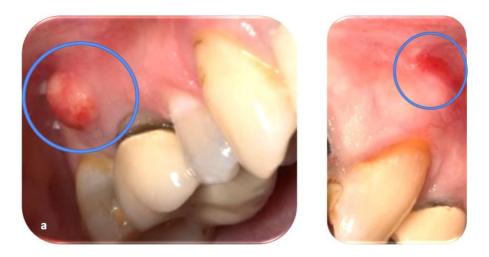
Figure 3 Clinical pre-operative photographs. (a) Buccal sinus with pus exuding adjacent to 16 (b) Red patch in buccal sulcus adjacent to 23.

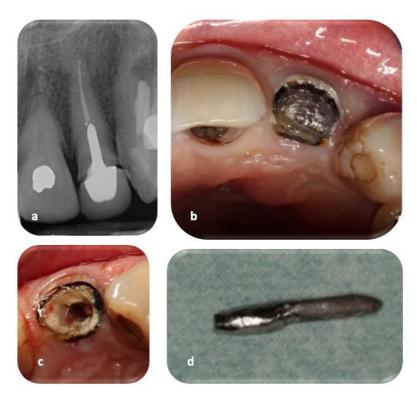
Figure 6 (a) Pre-operative radiograph tooth 22 (b)The crown (c,d) and post from tooth 22 was removed.

Tooth 22 was originally restored with a wide metal post. This was problematic to remove as the post was highly retentive and it was imperative to maintain the remaining tooth structure. The tooth was restored with a fibre post and metal ceramic crown. Studies have shown that fibre posts are associated with lower catastrophic failure in comparison to cast metal posts (Ferrarri et al 2000). Fibre posts offer a modulus of elasticity similar, to that of dentine which results in lower stress concentration at the post – dentine interface, reducing the incidence of root fracture (Pegoretti et al 2002). Fibre posts can also be placed immediately after root canal treatment, thus reducing the chance of inter-appointment leakage.

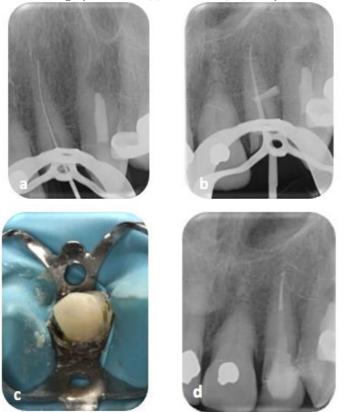
Figure 7 PA radiographs of tooth 22 (a) Working length 22 (b) Master cone 22 (c) Photograph of tooth 22 after post and core placement (d) Postoperative.

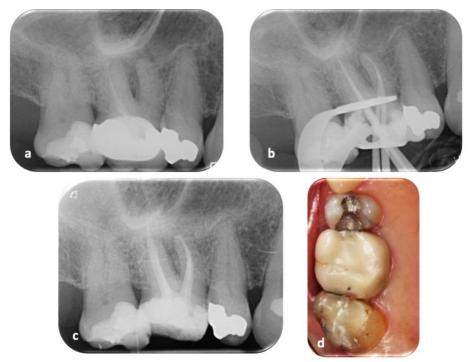
Figure 8 PA radiographs of tooth 16 (a) Pre-operative (b) Master cone 16 (c) Postoperative (d) Photograph after composite core placement.

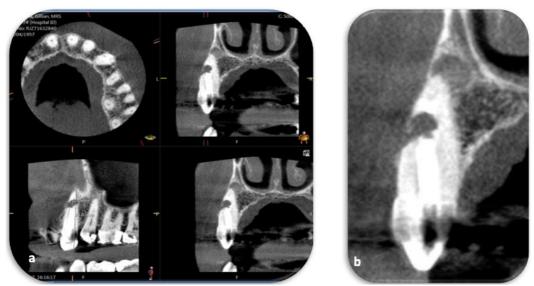
Figure 11 Pre-operative checks (a) CBCT in sagittal, axial and coronal planes (b) Sagittal view.

Tooth 23 was monitored, however, after persistent symptoms a cone beam CT was taken which revealed root resorption in the apical third and an associated periapical lesion. Surgery was subsequently carried out. Due to the resorptive lesion in the apical third it was presumed that MTA was placed as an apical plug during the endodontic treatment carried out by the endodontist the patient originally saw. However, during the surgical procedure gutta percha was found. MTA has been shown to be a biocompatible material that is useful in endodontic procedures such as root repair and endodontic healing and was therefore, used as the apical filling material during the surgical procedure (Schwartz et al 1999, Schmitt et al 2001, Bramente et al 2006). At twelve months there was good evidence of periapical healing.

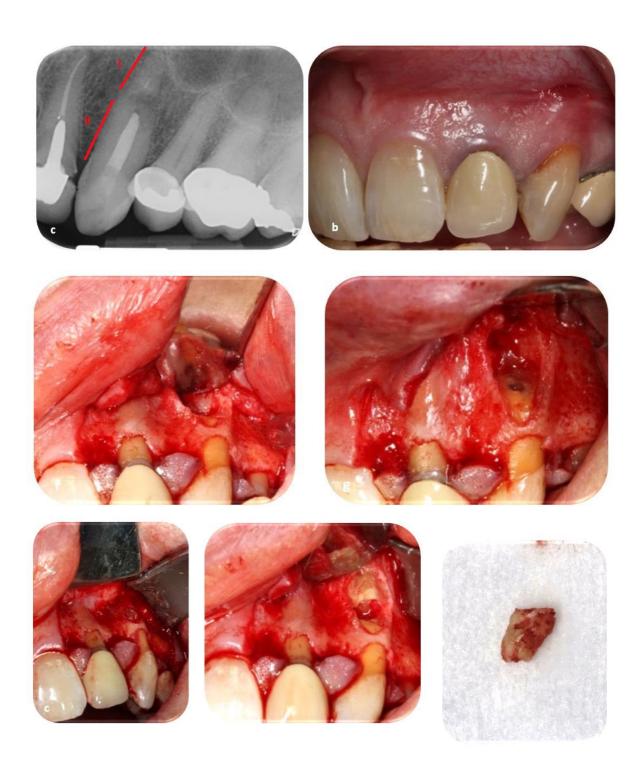
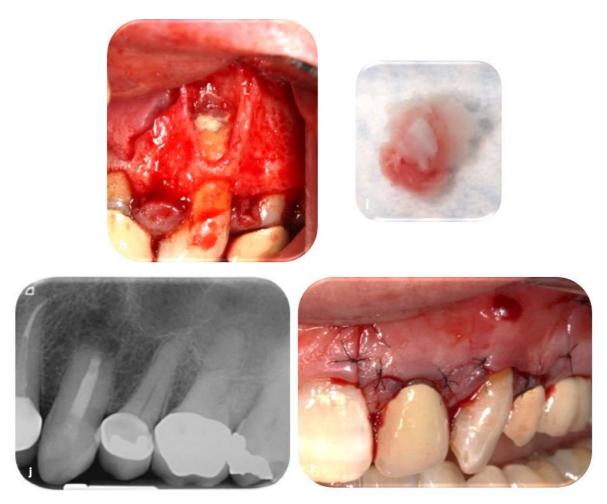
Figure 12 Apical surgery of tooth 23 (a) Pre-operative radiograph (i) length between resorptive area and apex of 23 (ii) length of the root to resorptive area (b) Pre-operative photograph (c)Surgical access, osteotomy site and retraction soft tissue (d) Exposure of resorptive area and apical root (e) 5mm of resected root (f) Site after removal of apical root (g) 3mm ultrasonic retrograde preparation of the canals (h) Haemostasis achieved and MTA retrofilling (i) Histology tissue sample (j)Postoperative radiograph (k) Postoperative photograph

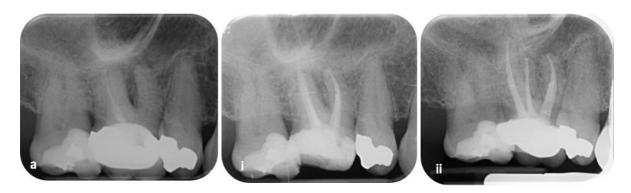
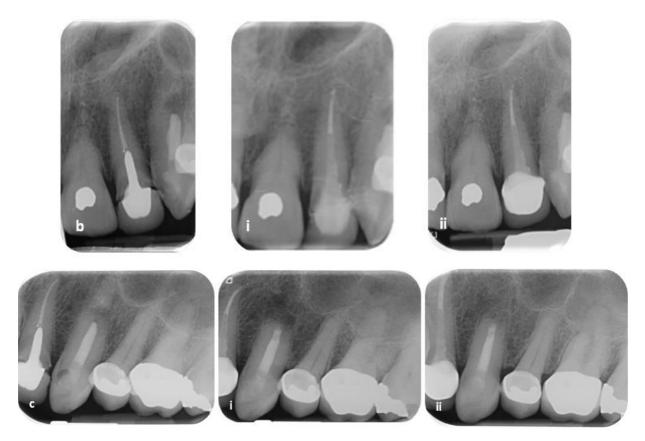
Figure 13 Radiographic review tooth 16 (a) Pre-operative (ai) Postoperative (aii) 1 Year review, tooth 22 (b) Pre-operative (bi) Postoperative (bii), 1 Year review tooth 23 (c) Pre-operative (ci) Postoperative (cii) 6 months review
