Treatment plan

This case demonstrated the management of a three rooted maxillary premolar and perforation repair.

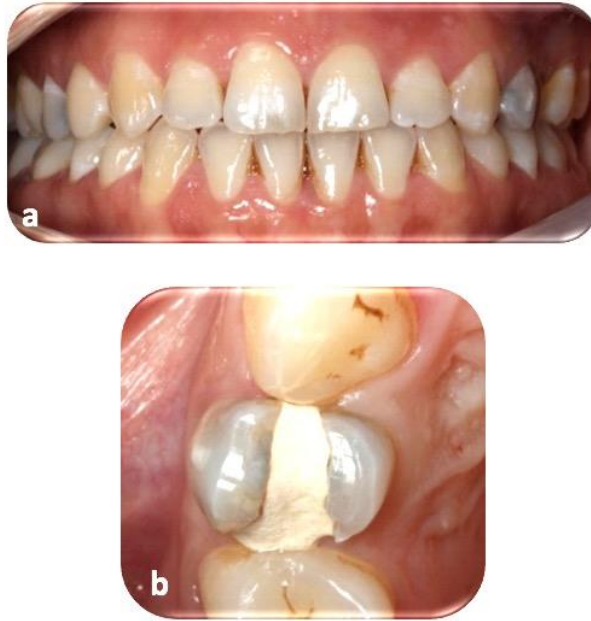
Figure 2 Clinical pre-operative photographs. (a) Labial view (b) Occlusal view tooth 24

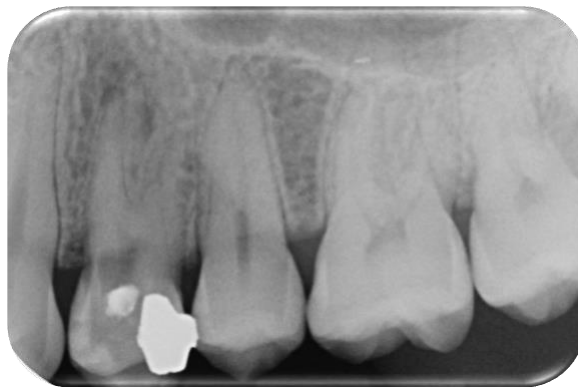
Figure 3 Pre-operative PA radiograph of tooth 24

In this case, the additional root was visible on the radiograph and the canals identifiable with the use of an operating microscope.
