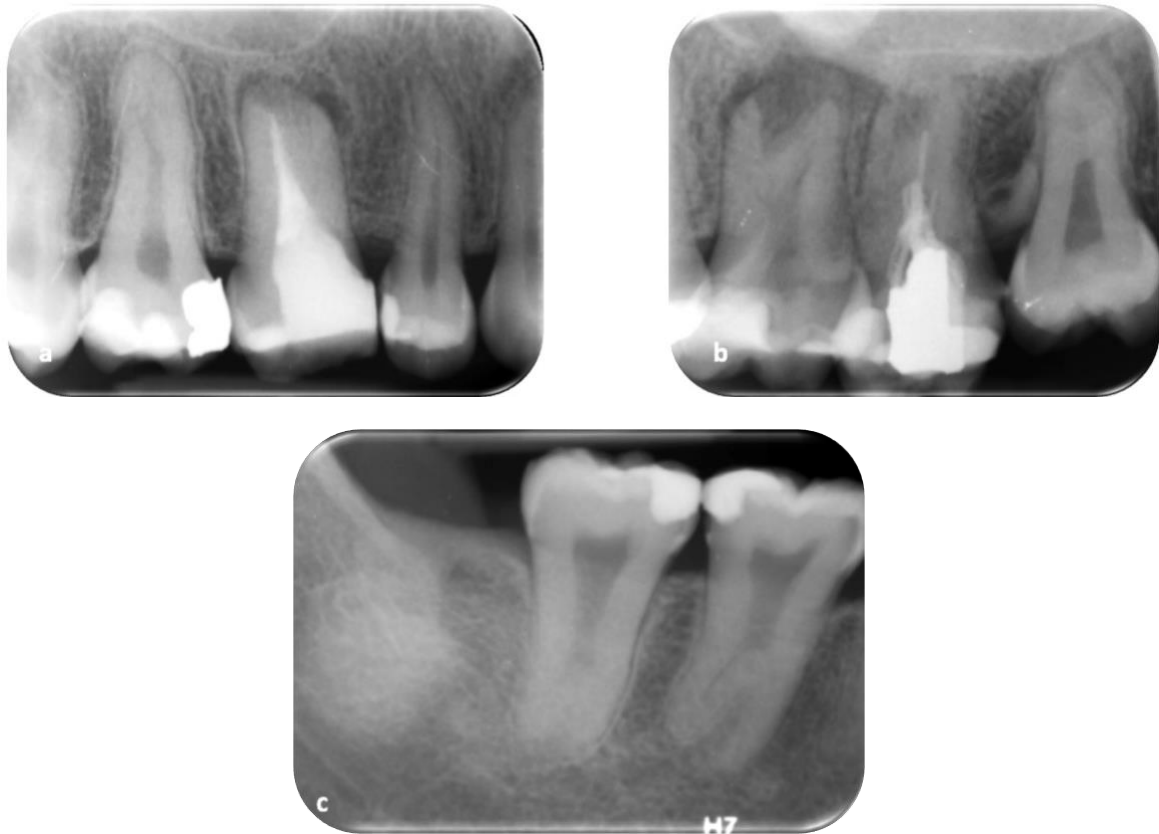
Figure 3 Pre-operative PA radiographs of teeth 16, 26, 27, 46 and 47

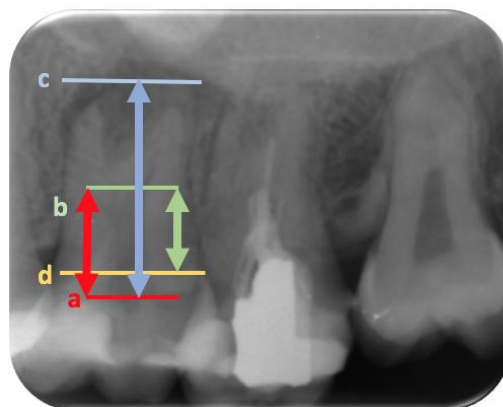
Figure 5 Taurondont Classification by Shifam and Chanannel 1978 applied to tooth 26. (a) lowest point of the roof of the pulp chamber (b) to the highest point of pulp floor, when divided by the distance from (a) to root apex (c) should be equal to or greater than 0.2 mm and/or distance from (b) to cement-enamel junction (d) should be greater than 2.5 mm

The term taurodontism derives from both latin and greek, meaning ‘bull tooth’. It is used to describe the developmental disturbance of a tooth resulting in a lack of constriction at the level of the cemento-enamel junction, vertically elongated pulp chambers, apical displacement of the pulp floor and bifurcation or trifurcation of the roots.

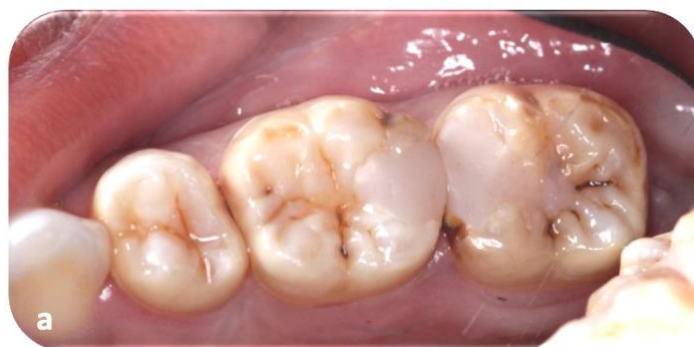
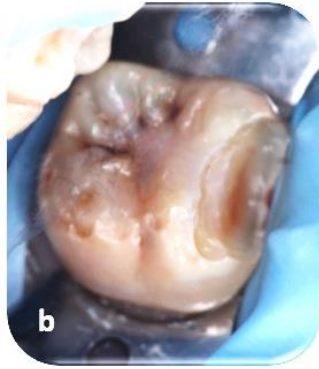
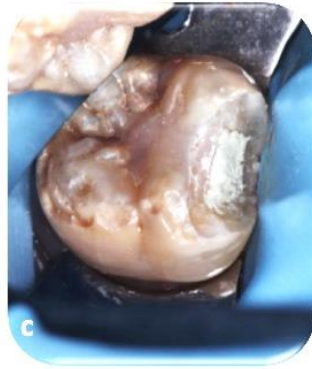
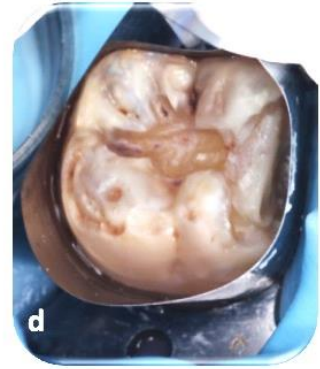
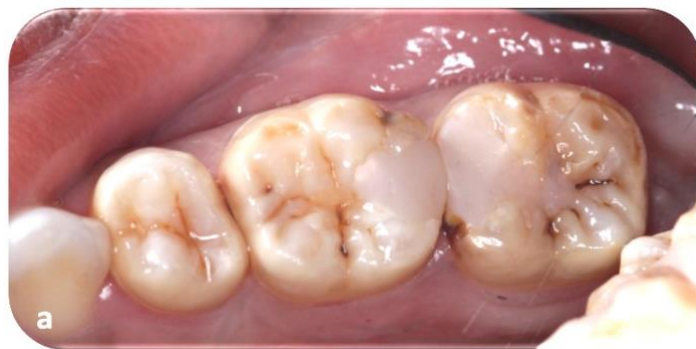
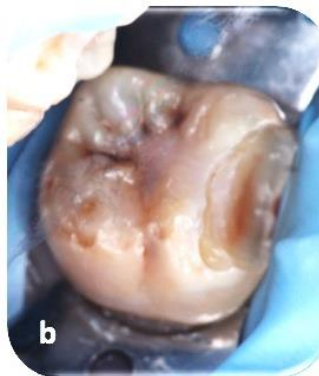
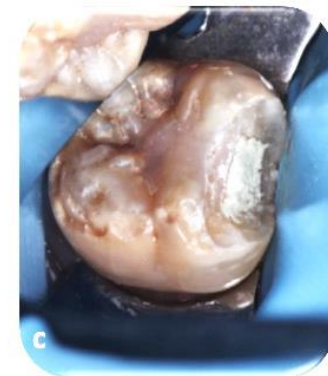
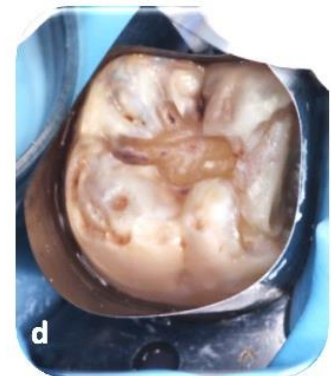
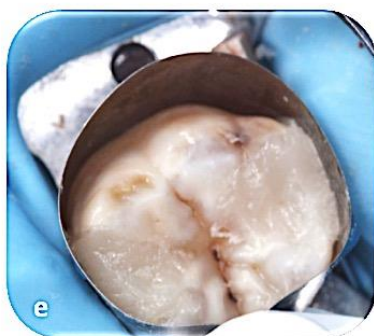
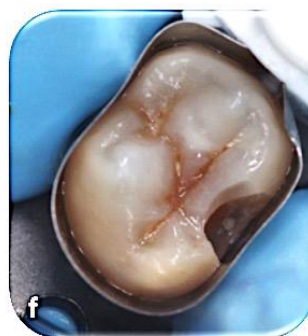
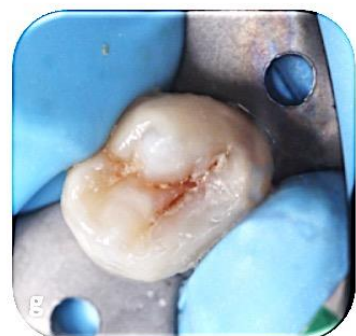
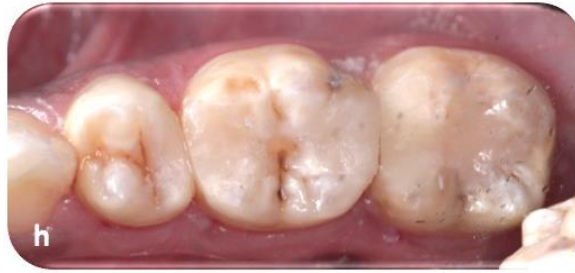
Figure 6 Clinical photographs of the indirect pulp cap on tooth 47. (a) Pre-operative (b) Caries removed 47 and extends close to the mesial pulp horn (c) MTA pulp cap 47 (d) GIC used to cover the MTA 47. An Automatrix and wedge placed prior to composite restoration. Composite placed tooth 47 (e) caries removal and matric placement (f) composite placement tooth 45 (h) Postoperative photograph tooth 45, 46, 47.

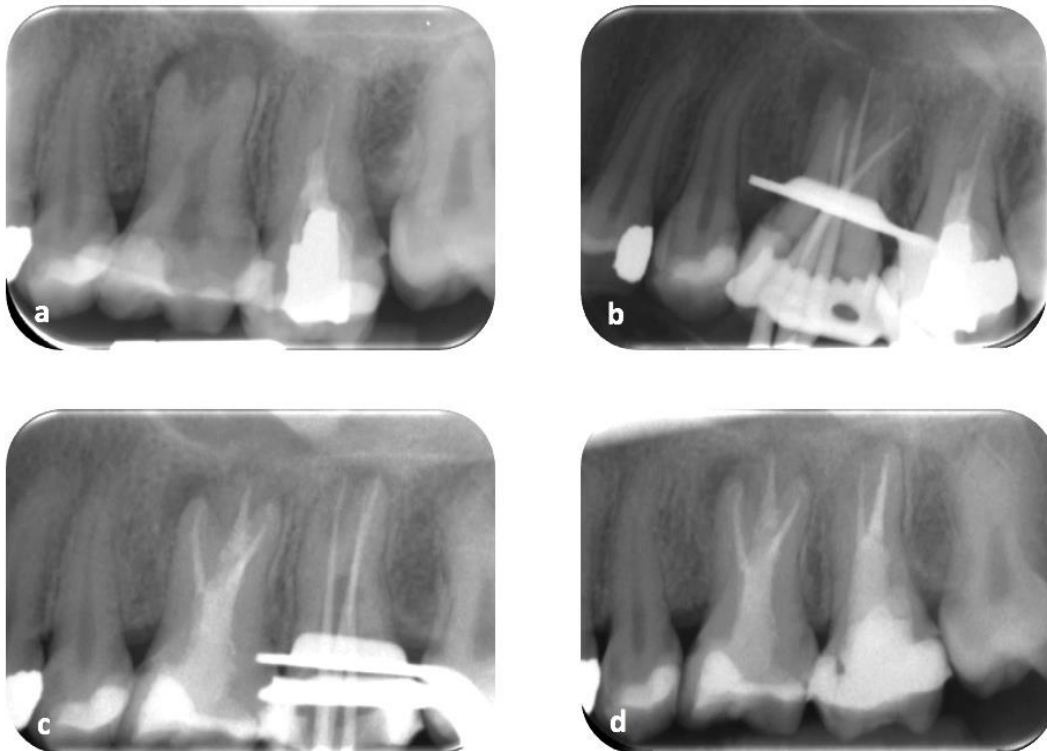
Figure 7 PA radiographs of tooth 26 and 27 (a) Pre-operative (b) Master cone 36 (c) Master cone 27 (d) Postoperative.

All teeth were dressed with calcium hydroxide between appointments to try and reduce bacterial levels and irrigation was activated by sonic activation to increase the efficiency of penetration into areas of difficult anatomy (Virdee et al 2018).

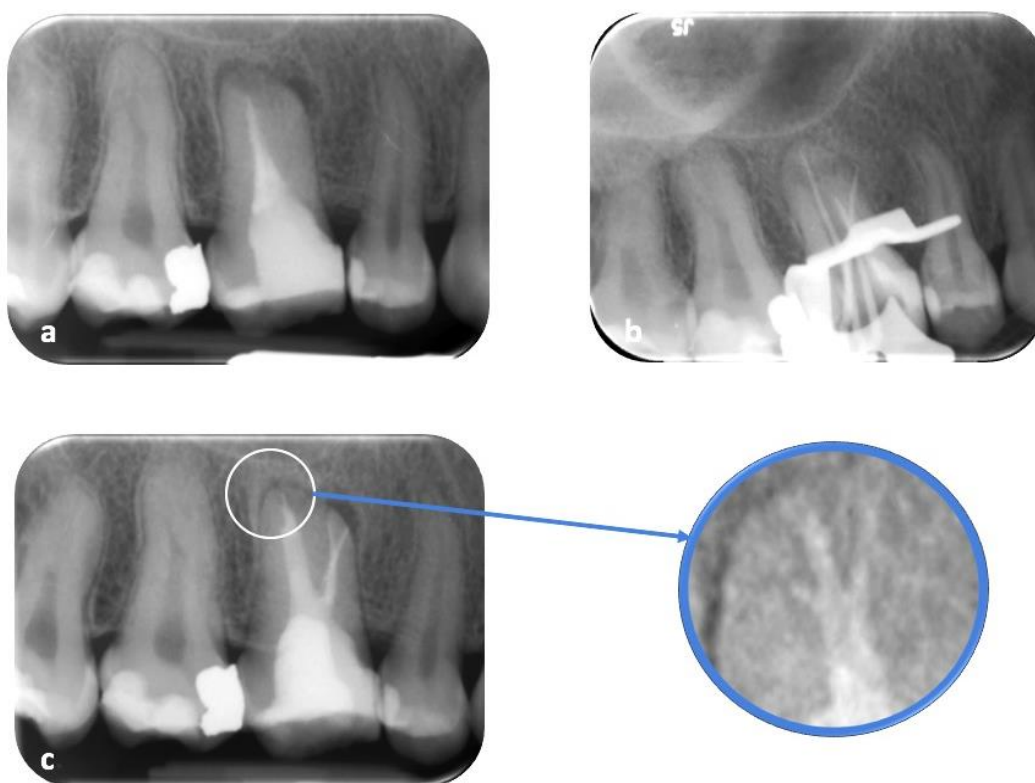
Figure 8 PA radiographs of tooth 16 (a) Pre-operative (b) Master cone of tooth (c) Postoperative radiograph, highlighting apical delta

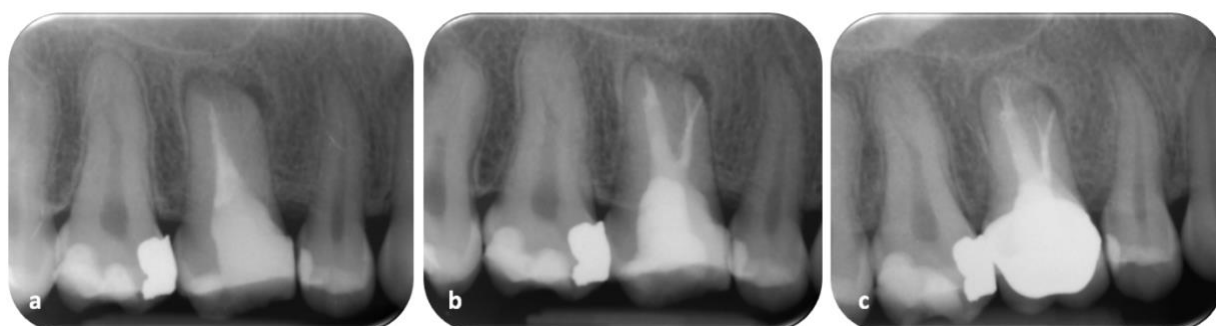
Figure 11 Review of teeth 16, 26 and 27 (a) Pre-operative radiograph (b) Postoperative radiograph (c) 1-year review, showing periapical radiolucency is less dense

At one year review the patient has no clinical signs or symptoms and radiographically there was a significant reduction in the size of the apical radiolucencies of all treated teeth.

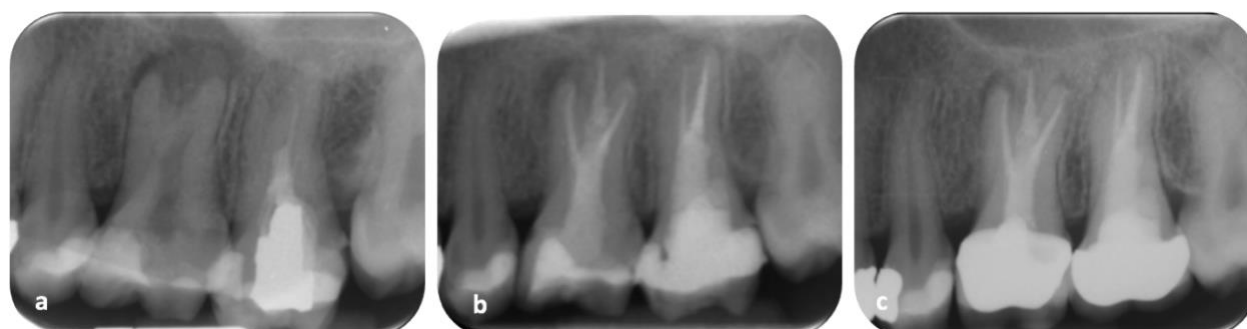
Figure 12 Review of teeth 26 and 27 (a) Pre-operative radiograph (b) Postoperative radiograph (c) 1-year review, showing periapical radiolucency is less dense
