Lower premolar three rooted

This patient was referred to me after Root canal treatment of tooth 34 was initiated by the patients GDP however the canals could not be located. The tooth was causing a dull throbbing pain and was tender to bite on.

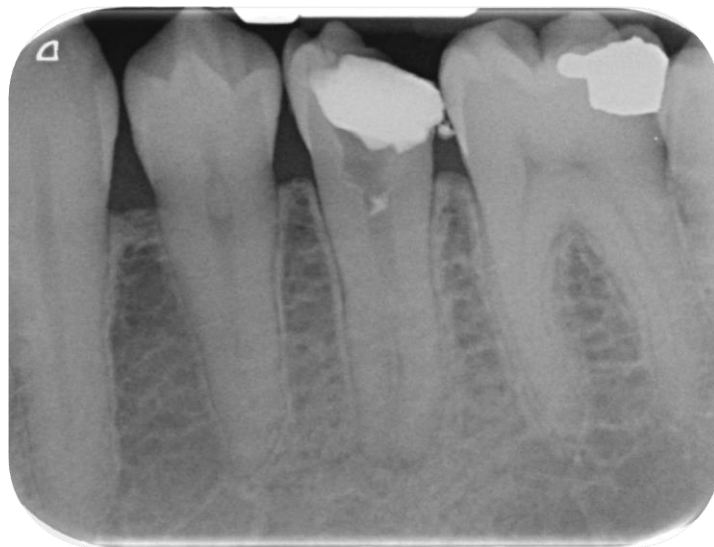
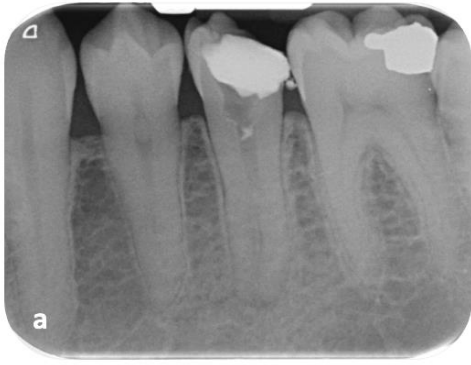
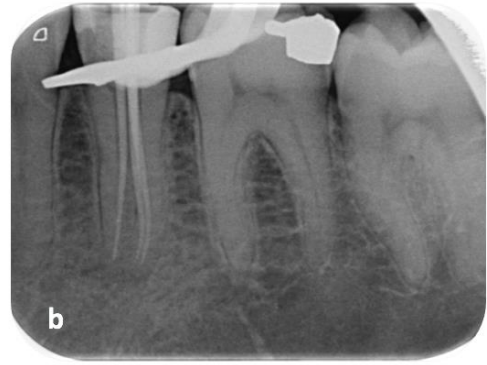
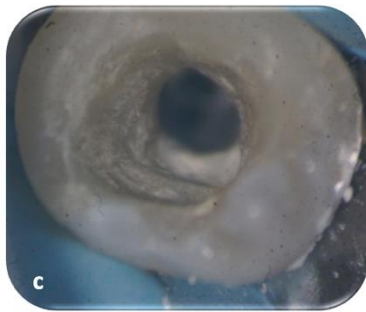
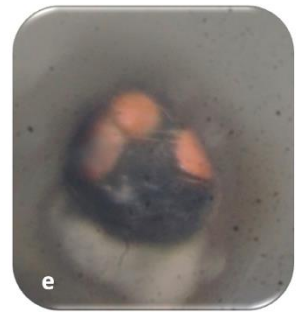
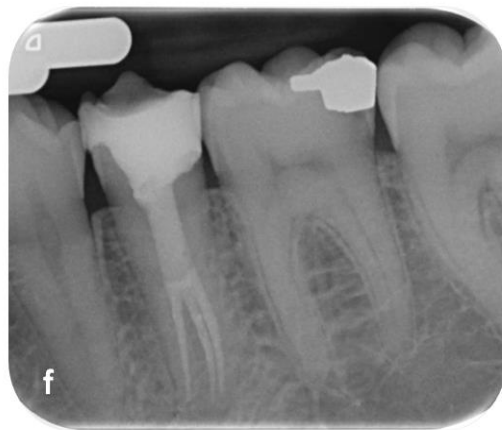
Such cases are detected through thorough radiographic interpretation, close evaluation of the pulp chamber floor and adequate access. In this case the root canal trifurcated in the middle half of the root. Identification and management of all canals is essential in order to achieve endodontic success (Wolcott et al 2005). The use of an operating microscope, which was also essential in adequate chemo-mechanical and obturation of the canals.

All endodontic treatment was carried out using a dental operating microscope over two visits. Three canal orifices were located. Chemo-mechanical preparation was completed in the first visit. An inter-appointment calcium hydroxide dressing was placed in the root canal and at the next visit the tooth was obturated with gutta-percha and zinc oxide eugenol based sealer, using a warm vertical condensation technique

A composite resin core was placed immediately following obturation.
